**Flood Control Project Maintenance
Levee Inspections**

Spring 2012 Levee Inspection Results

Sacramento Maintenance Yard Maintenance Area 0009

Waterway			Bank	Unit Miles
Unit No. 01 Sacramento River			Left	19.61
	Spring (March - May)	Summer (June - August)	(September - November) Fall	Winter (December - February)
Unit Maintenance Rating (Fall Only)				
Date of Inspection	5/1/2012 - 5/2/2012			
DWR Inspector	John Williamson			
Accompanied By	Dave Williams Sacramento Maint.			
	Iris Flores Sacramento Maint.

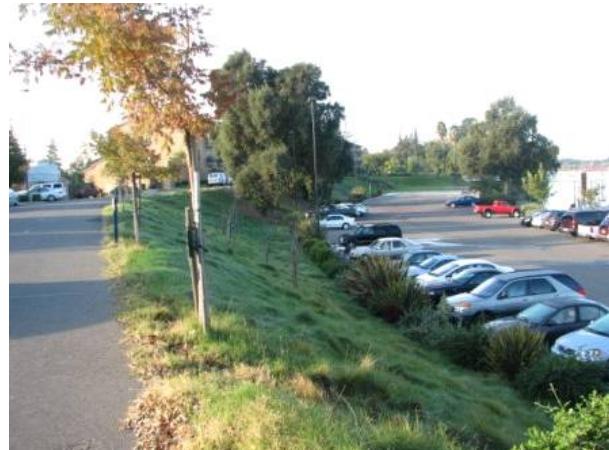
Levee Mile Report Line	6
Start Levee Mile	0.48
End Levee Mile	0.65
Location	Water Side
Category	Earthen Levee
Item	Vegetation
Landscape on the waterside at Le Rivage Hotel. Fall 2011	
<i>johngw_s_20120313_030.jpg</i>

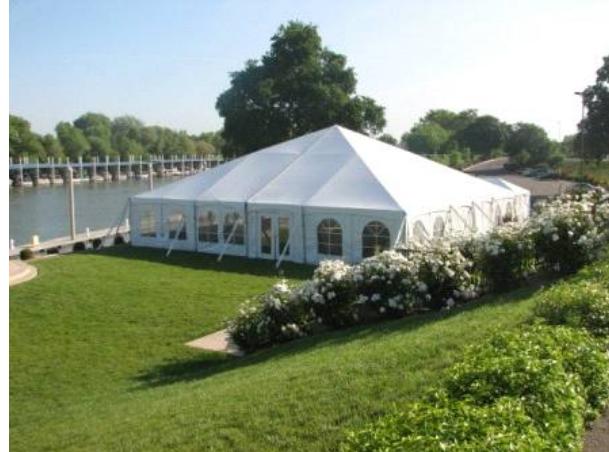
johngw_s_20120504_749.jpg

This is the seasonal wedding tent in the flood plan. Photo taken spring 2012.

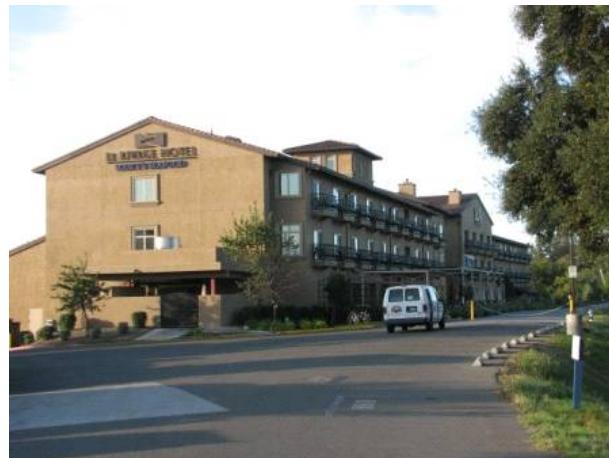
johngw_s_20120313_121.jpg

Hotel and restaurant at old Captain's Table, Le Rivage Hotel. Fall 2011

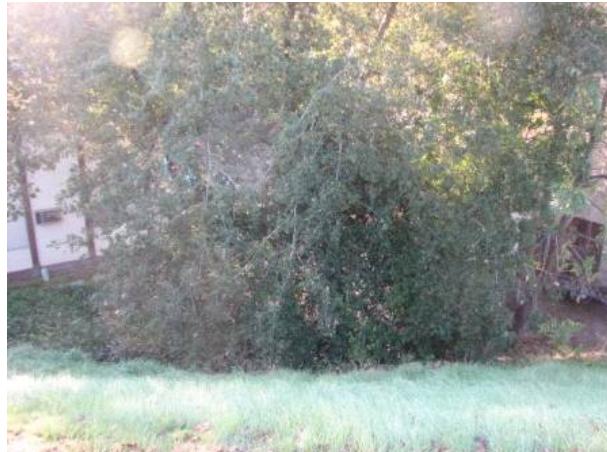
Levee Mile Report Line	10
Start Levee Mile	0.68
End Levee Mile	0.68
Location	Land Side
Category	Earthen Levee
Item	Trim / Thin Trees
The trees need trimming that are located at the apartments. Fall 2011	
johngw_s_20120313_023.jpg

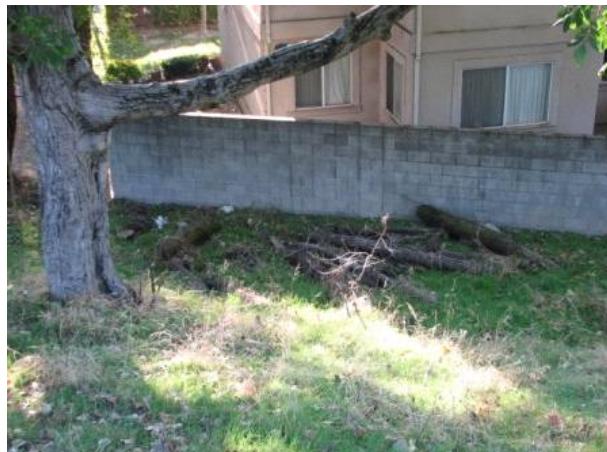
Levee Mile Report Line	11
Start Levee Mile	0.72
End Levee Mile	0.72
Location	Land Side
Category	Earthen Levee
Item	Encroachments
Tree limbs and brush at the toe left from trimming trees. Fall 2011	
johngw_s_20120313_128.jpg

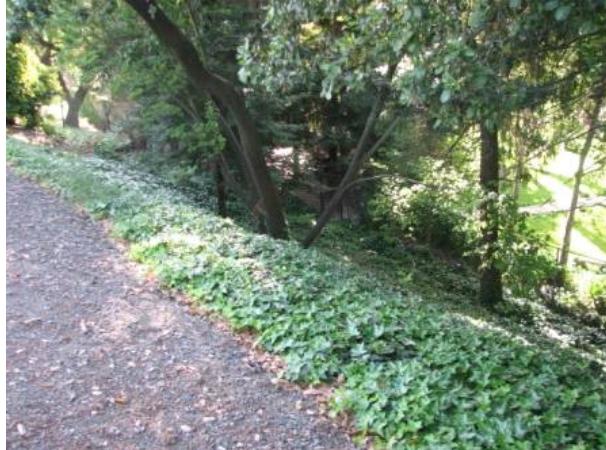
johngw_s_20120504_750.jpg

The groundcover (ivy) covers the levee slope.
Photo taken spring 2012.

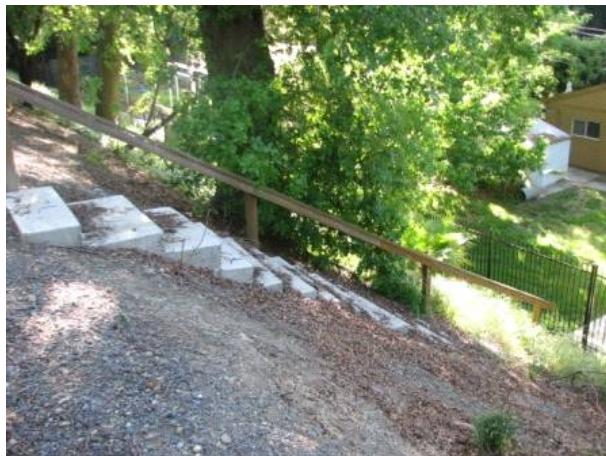
johngw_s_20120504_751.jpg

A view of the landscape and stairs. Photo taken spring 2012.

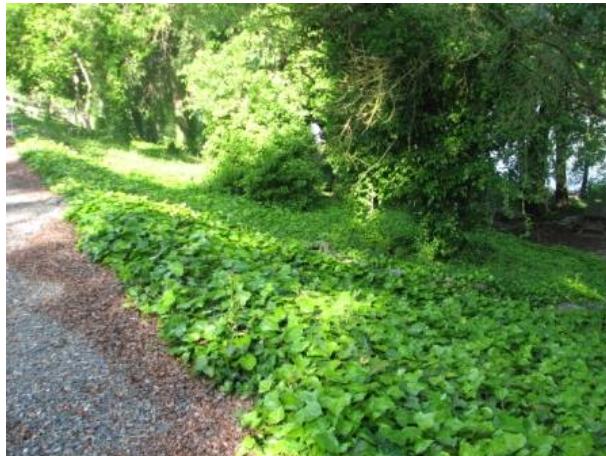
johngw_s_20120504_752.jpg

The groundcover (ivy) covers the levee slope and climbs the trees. Photo taken spring 2012

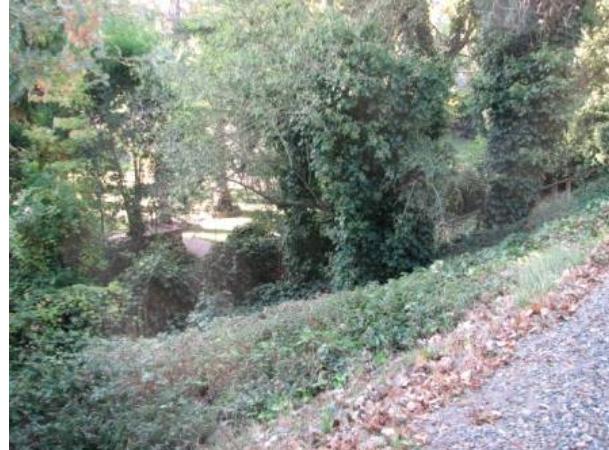
Levee Mile Report Line	17
Start Levee Mile	0.88
End Levee Mile	0.90
Location	Land Side
Category	Earthen Levee
Item	Vegetation
Ivy groundcover completely covers the ground and makes it hard too see seepage. Fall 2011	johngw_s_20120313_035.jpg

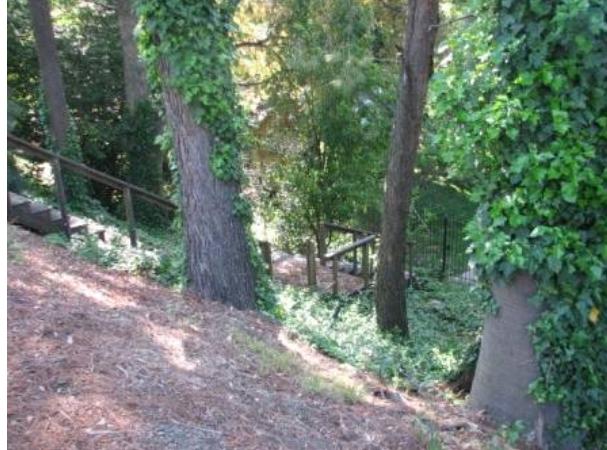
Levee Mile Report Line	22
Start Levee Mile	1.00
End Levee Mile	1.02
Location	Land Side
Category	Earthen Levee
Item	Vegetation
Groundcover is climbing into the trees. Photo taken spring 2012.	
<i>johngw_s_20120504_753.jpg</i>

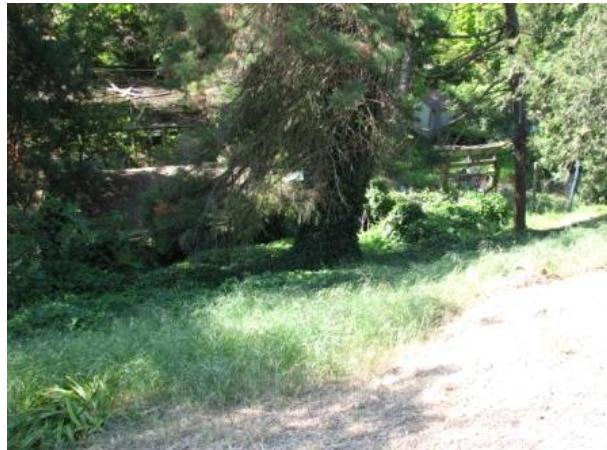
Levee Mile Report Line	24
Start Levee Mile	1.04
End Levee Mile	1.06
Location	Land Side
Category	Earthen Levee
Item	Vegetation
The overgrown landscape makes it hard to see.	
<i>johngw_s_20120313_044.jpg</i>

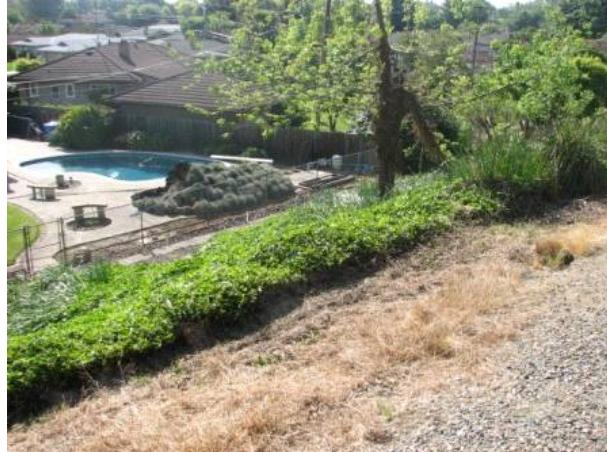
Levee Mile Report Line	33
Start Levee Mile	1.36
End Levee Mile	1.36
Location	Land Side
Category	Earthen Levee
Item	Vegetation
The groundcover covers the levee slope. Photo taken spring 2012.	
johngw_s_20120504_754.jpg

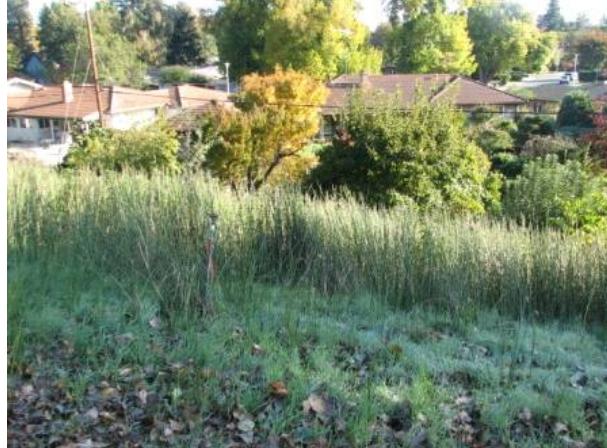
Levee Mile Report Line	36
Start Levee Mile	1.41
End Levee Mile	1.41
Location	Land Side
Category	Earthen Levee
Item	Vegetation
Horsetail vegetation completely blocks levee slope. Fall 2011	
johngw_s_20120313_129.jpg

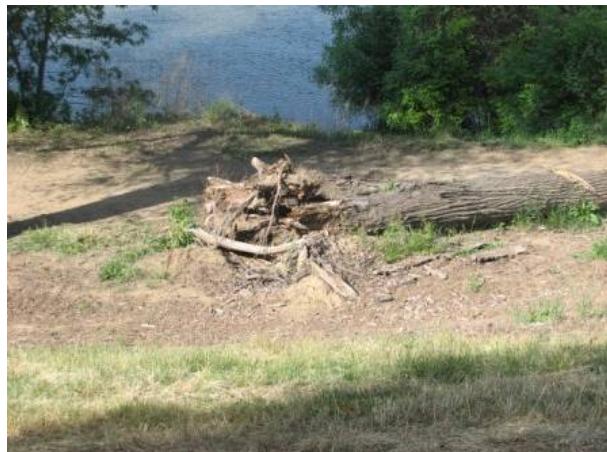
Levee Mile Report Line	37
Start Levee Mile	1.56
End Levee Mile	1.56
Location	Water Side
Category	Earthen Levee
Item	Encroachments
A tree has fallen and the roots have left a hole in the berm. Photo taken spring 2012.	
johngw_s_20120504_756.jpg

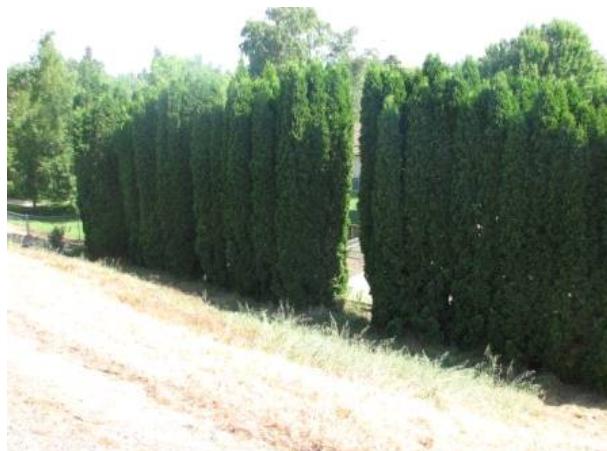
Levee Mile Report Line	38
Start Levee Mile	1.62
End Levee Mile	1.63
Location	Land Side
Category	Earthen Levee
Item	Vegetation
The hedge of trees make it hard to the toe of the levee. Photo taken spring 2012.	
johngw_s_20120504_757.jpg

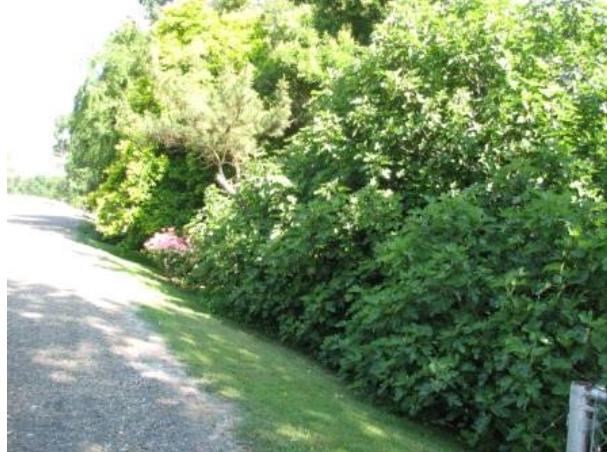
Levee Mile Report Line	39
Start Levee Mile	1.88
End Levee Mile	1.92
Location	Land Side
Category	Earthen Levee
Item	Vegetation
The trees and vegetation makes it hard to see the toe.	
<i>johngw_s_20120313_056.jpg</i>

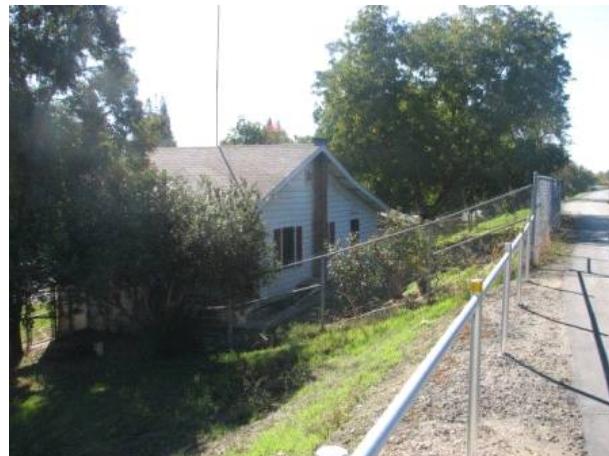
johngw_s_20120313_058.jpg

House is located on the levee slope and garden is terraced into the slope.

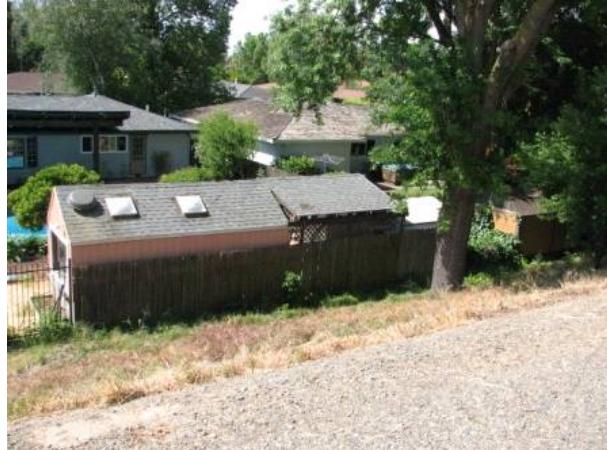
Levee Mile Report Line	43
Start Levee Mile	2.81
End Levee Mile	2.81
Location	Land Side
Category	Earthen Levee
Item	Encroachments
The wooden fence and building are along the toe of the levee.	
johngw_s_20120313_059.jpg

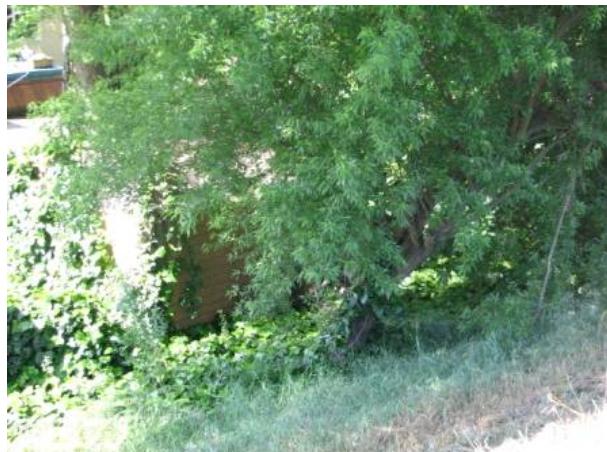
Levee Mile Report Line	44
Start Levee Mile	2.82
End Levee Mile	2.82
Location	Land Side
Category	Earthen Levee
Item	Encroachments
There is a building under the groundcover at the toe of the levee. Photo taken spring 2012.	
johngw_s_20120504_758.jpg

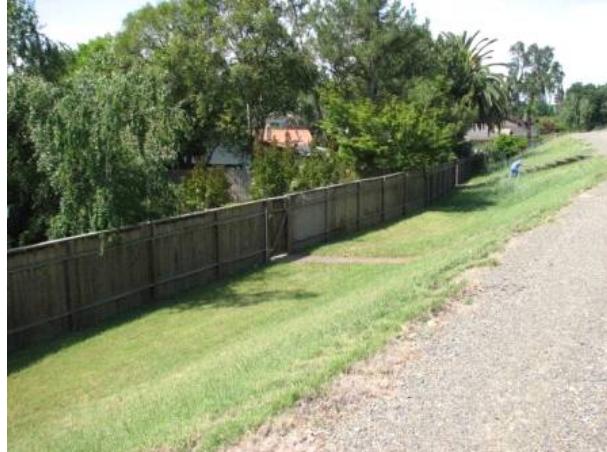
Levee Mile Report Line	55
Start Levee Mile	3.06
End Levee Mile	3.12
Location	Land Side
Category	Earthen Levee
Item	Encroachments
Several homes have solid fences and make it hard to see.	
johngw_s_20120313_066.jpg

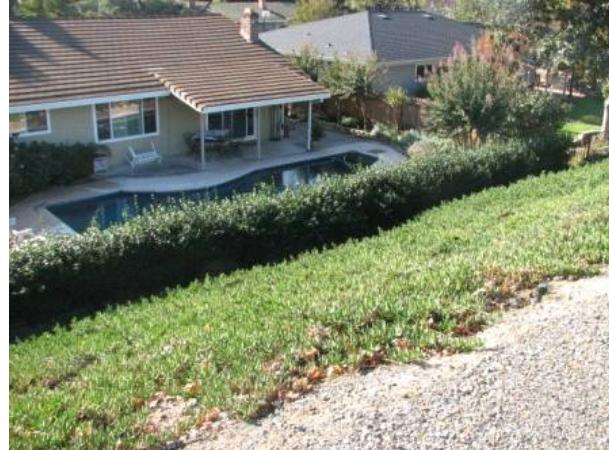
Levee Mile Report Line	68
Start Levee Mile	3.28
End Levee Mile	3.30
Location	Land Side
Category	Earthen Levee
Item	Encroachments
A fence and retaining wall with star jasmine growing on it blocks view of the toe. Fall 2011	
johngw_s_20120313_067.jpg

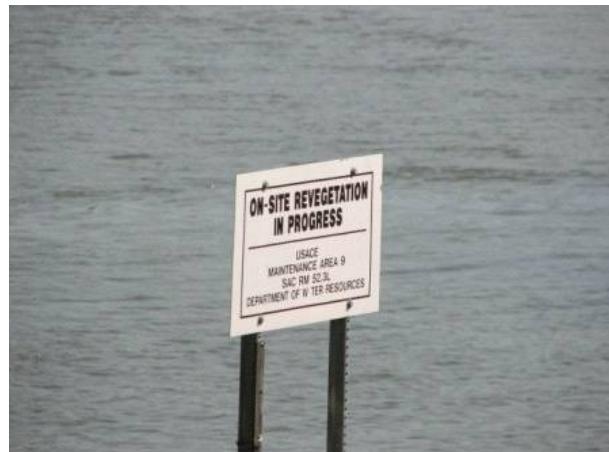
Levee Mile Report Line	72
Start Levee Mile	3.33
End Levee Mile	3.56
Location	Land Side
Category	Earthen Levee
Item	Vegetation
A revegetation site. Photo taken spring 2012.	
johngw_s_20120504_759.jpg

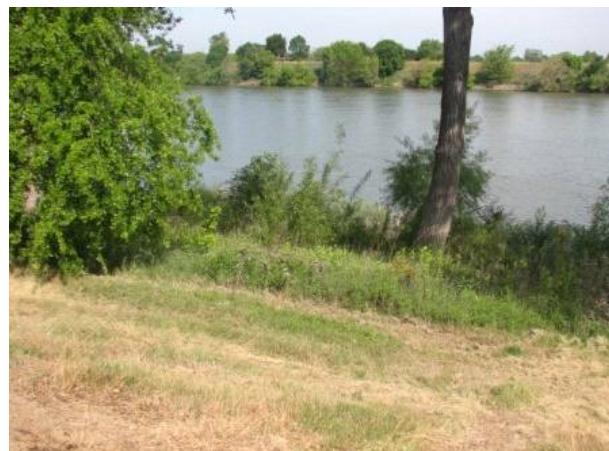
Levee Mile Report Line	72
Start Levee Mile	3.33
End Levee Mile	3.56
Location	Land Side
Category	Earthen Levee
Item	Vegetation
A revegetation site.	
johngw_s_20120504_760.jpg

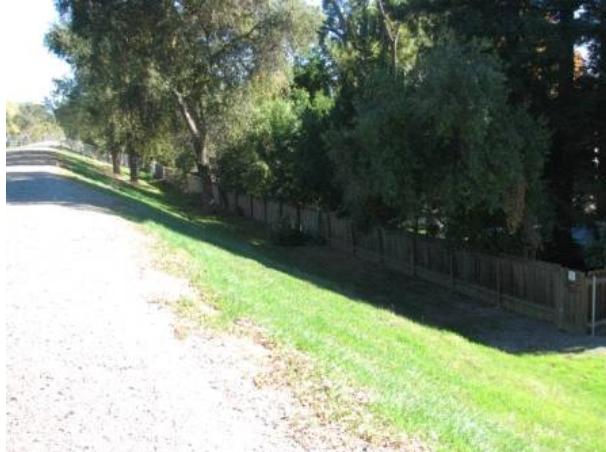
Levee Mile Report Line	73
Start Levee Mile	3.34
End Levee Mile	3.37
Location	Land Side
Category	Earthen Levee
Item	Encroachments
The wooden fence is along the toe of the levee.	
<i>johngw_s_20120313_068.jpg</i>

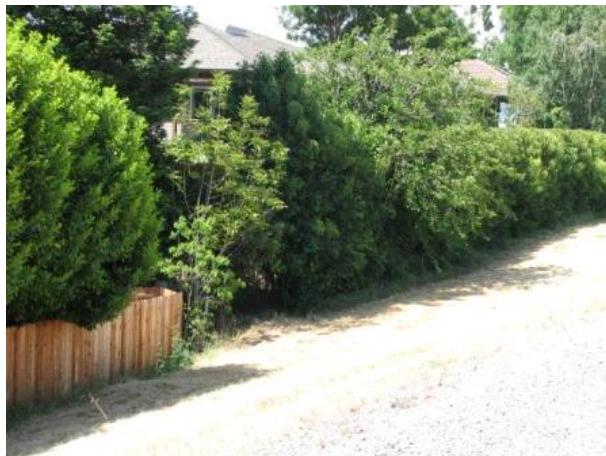
Levee Mile Report Line	74
Start Levee Mile	3.60
End Levee Mile	3.62
Location	Land Side
Category	Earthen Levee
Item	Encroachments
Rebuilding the fence with solid boards. Vines and shrubs completely block visibility.	
<i>johngw_s_20120313_069.jpg</i>

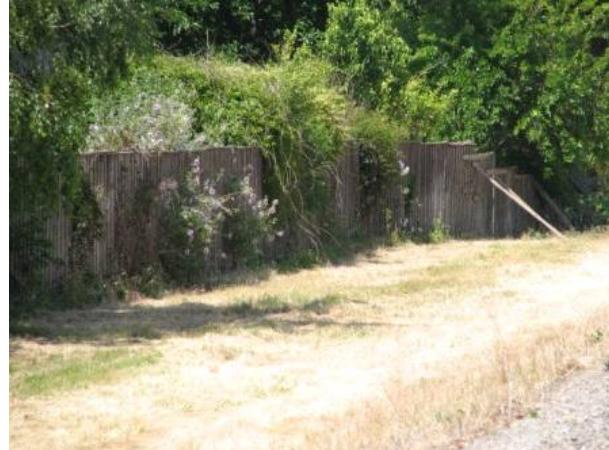
Levee Mile Report Line	76
Start Levee Mile	3.65
End Levee Mile	3.69
Location	Land Side
Category	Earthen Levee
Item	Encroachments
The fence is of solid construction and blocks visibility.	
<i>johngw_s_20120313_070.jpg</i>

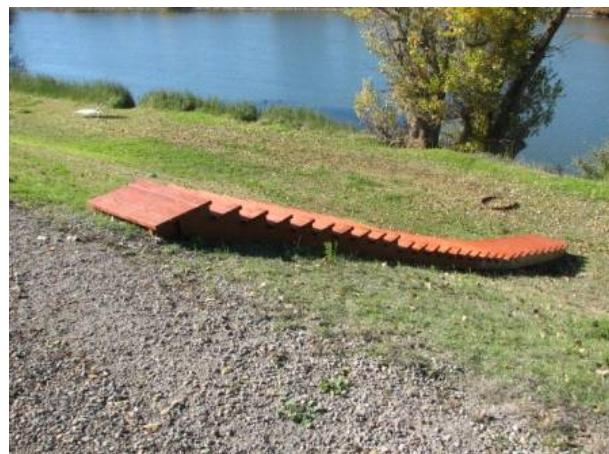
Levee Mile Report Line	95
Start Levee Mile	3.96
End Levee Mile	3.98
Location	Land Side
Category	Earthen Levee
Item	Vegetation
Wooden stairs are on the waterside levee slope.	
<i>johngw_s_20120313_071.jpg</i>

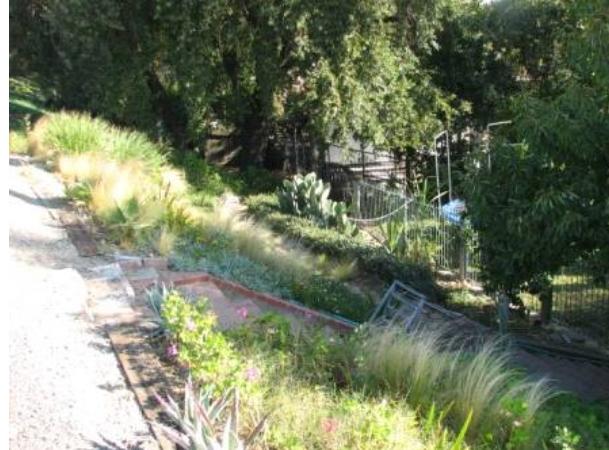
Levee Mile Report Line	100
Start Levee Mile	4.05
End Levee Mile	4.07
Location	Land Side
Category	Earthen Levee
Item	Vegetation
The homeowner has planted cactus and other shrubs landscaped with steps. Fall 2011	
johngw_s_20120313_073.jpg

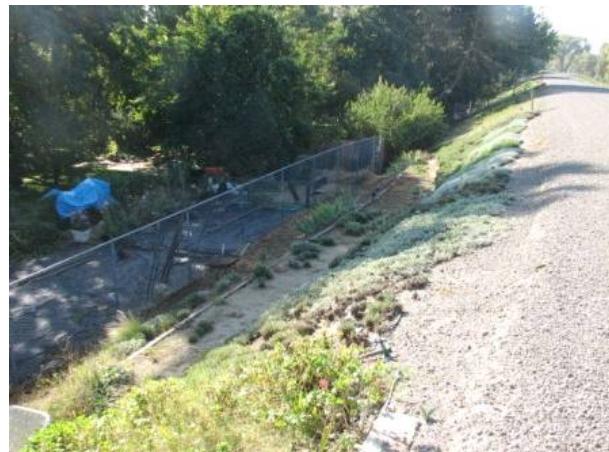
Levee Mile Report Line	101
Start Levee Mile	4.07
End Levee Mile	4.08
Location	Land Side
Category	Earthen Levee
Item	Vegetation
The homeowner has planted groundcover and installed retaining walls. Fall 2011	
johngw_s_20120313_074.jpg

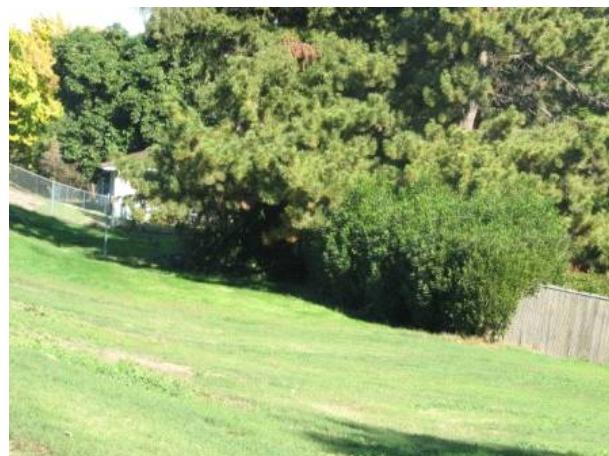
Levee Mile Report Line	106
Start Levee Mile	4.17
End Levee Mile	4.20
Location	Land Side
Category	Earthen Levee
Item	Encroachments
Fenced area with a walk through to the neighborhood. This is the City of Sacramento's property.	
johngw_s_20120313_075.jpg

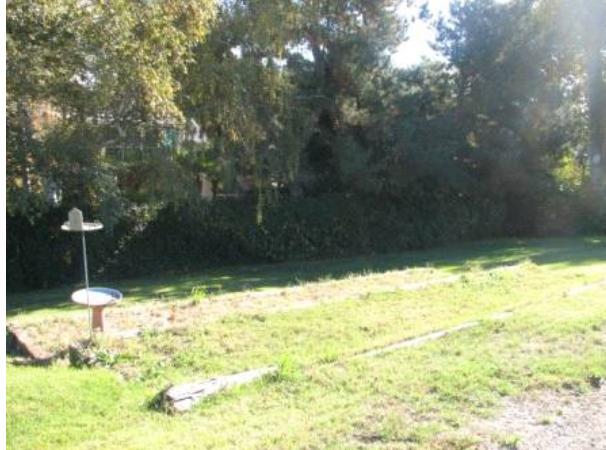
Levee Mile Report Line	107
Start Levee Mile	4.23
End Levee Mile	4.25
Location	Land Side
Category	Earthen Levee
Item	Encroachments
Landscaping and a fence on levee slope.	
johngw_s_20120313_076.jpg

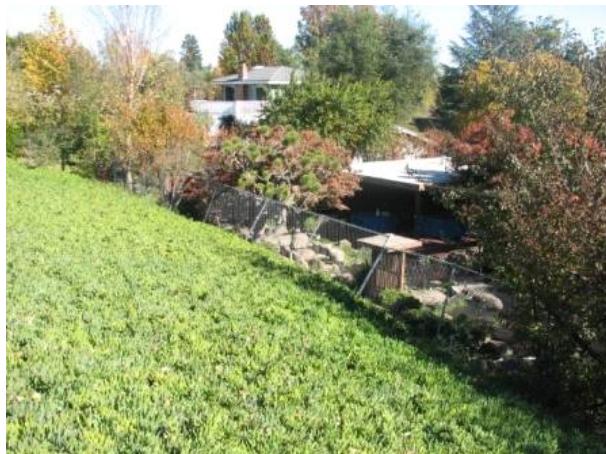
Levee Mile Report Line	110
Start Levee Mile	4.30
End Levee Mile	4.32
Location	Land Side
Category	Earthen Levee
Item	Vegetation
Chain link fence leaning towards the backyard with ice plant on the slope. The fence has been corrected.	
johngw_s_20120313_077.jpg

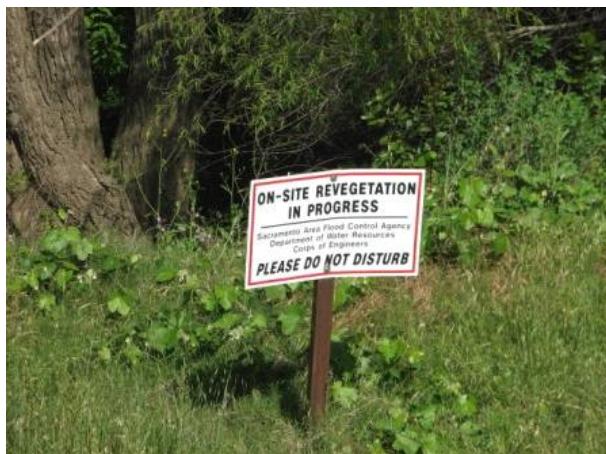
Levee Mile Report Line	111
Start Levee Mile	4.31
End Levee Mile	4.41
Location	Land Side
Category	Earthen Levee
Item	Vegetation
A revegetation site. Photo taken spring 2012.	
johngw_s_20120504_762.jpg

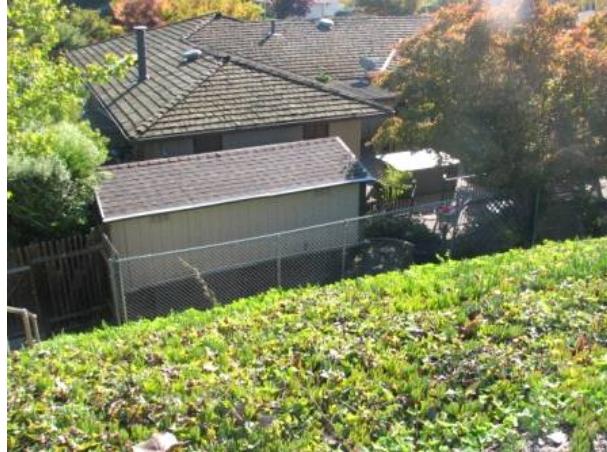
Levee Mile Report Line	121
Start Levee Mile	4.50
End Levee Mile	4.50
Location	Land Side
Category	Earthen Levee
Item	Encroachments
A small shed was built within the easement of the levee. Fall 2011	
<i>johngw_s_20120313_078.jpg</i>

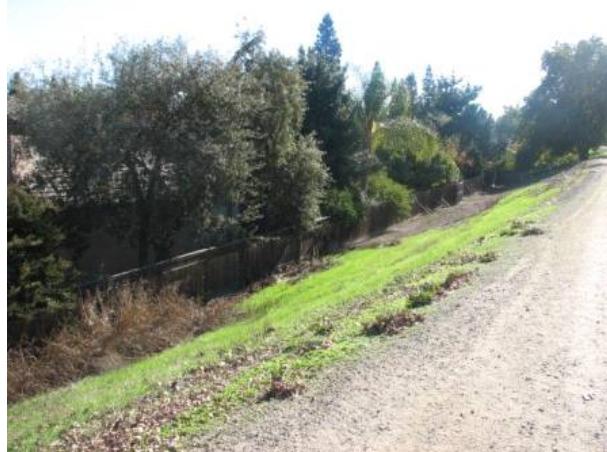
Levee Mile Report Line	128
Start Levee Mile	4.69
End Levee Mile	4.75
Location	Land Side
Category	Earthen Levee
Item	Encroachments
Wooden fence along the levee toe makes visibility difficult.	
<i>johngw_s_20120313_079.jpg</i>

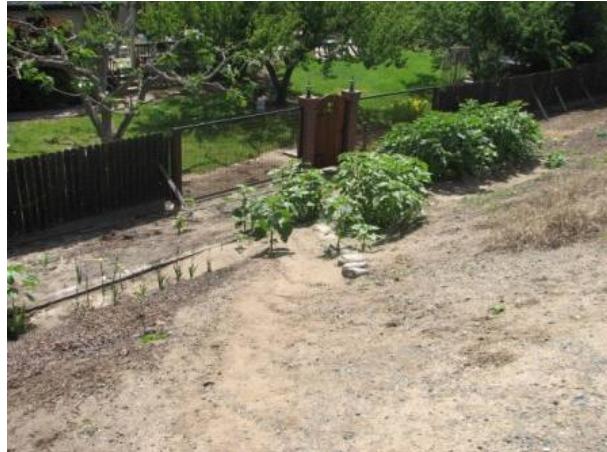
Levee Mile Report Line	129
Start Levee Mile	4.73
End Levee Mile	4.73
Location	Land Side
Category	Earthen Levee
Item	Vegetation
A vegetable garden with terraces has been planted on the levee slope. Photo taken spring 2012.	
<i>johngw_s_20120504_763.jpg</i>

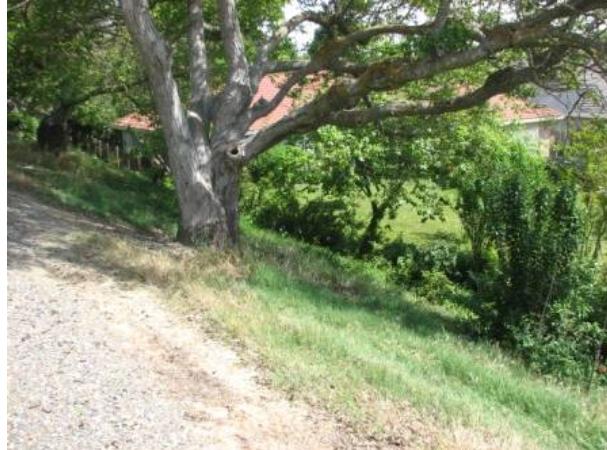
Levee Mile Report Line	130
Start Levee Mile	4.75
End Levee Mile	4.79
Location	Land Side
Category	Earthen Levee
Item	Vegetation
Trees and shrubs are on the levee slope. Photo taken spring 2012.	
johngw_s_20120504_764.jpg

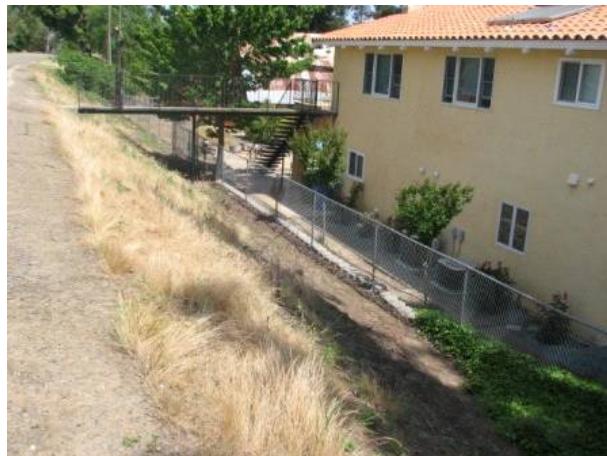
Levee Mile Report Line	132
Start Levee Mile	4.99
End Levee Mile	5.03
Location	Land Side
Category	Earthen Levee
Item	Vegetation
A retaining wall with a fence on top and some groundcover. Photo taken spring 2012.	
johngw_s_20120504_765.jpg

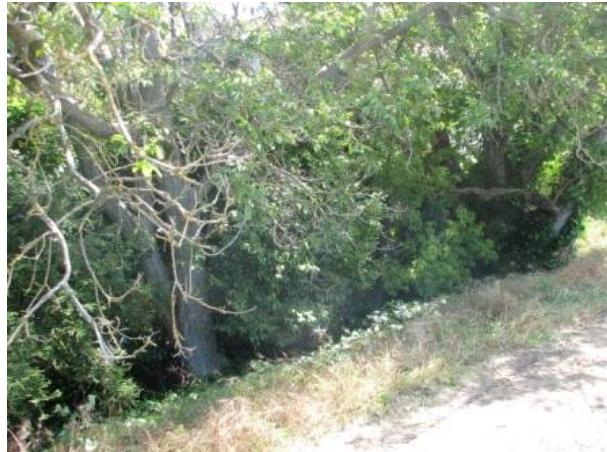
Levee Mile Report Line	134
Start Levee Mile	5.03
End Levee Mile	5.04
Location	Land Side
Category	Earthen Levee
Item	Vegetation
The landscape completely covers the levee slope. Photo taken spring 2012.	
<i>johngw_s_20120504_766.jpg</i>

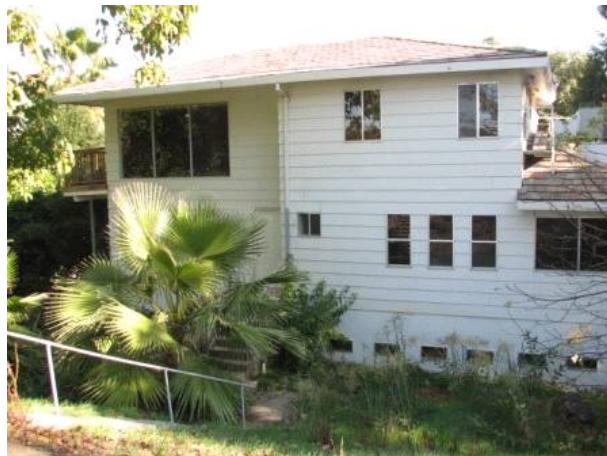
Levee Mile Report Line	135
Start Levee Mile	5.04
End Levee Mile	5.04
Location	Land Side
Category	Earthen Levee
Item	Encroachments
The house is within the easement of the levee. Fall 2011	
<i>johngw_s_20120313_081.jpg</i>

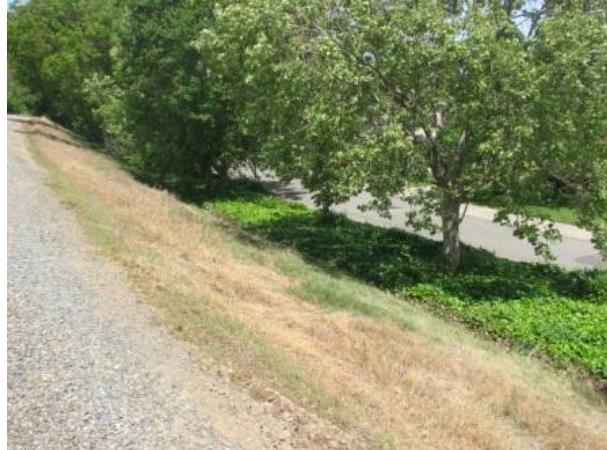
Levee Mile Report Line	137
Start Levee Mile	5.14
End Levee Mile	5.22
Location	Land Side
Category	Earthen Levee
Item	Vegetation
There is groundcover, trees and shrubs planted on the berm. Photo taken spring 2012.	
johngw_s_20120504_767.jpg

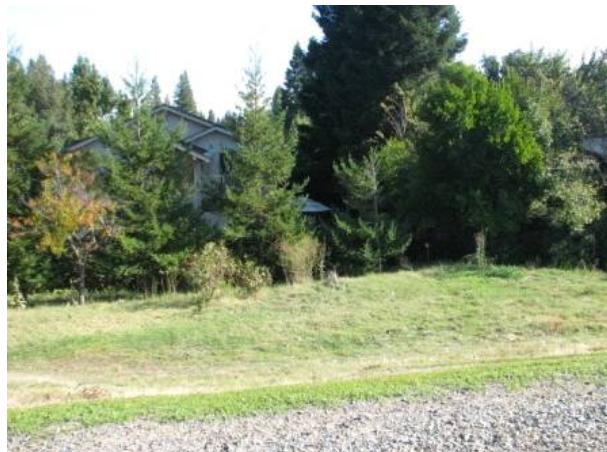
Levee Mile Report Line	138
Start Levee Mile	5.23
End Levee Mile	5.29
Location	Land Side
Category	Earthen Levee
Item	Encroachments
A fence and shrubs are on the levee slope. Fall 2011	
johngw_s_20120313_083.jpg

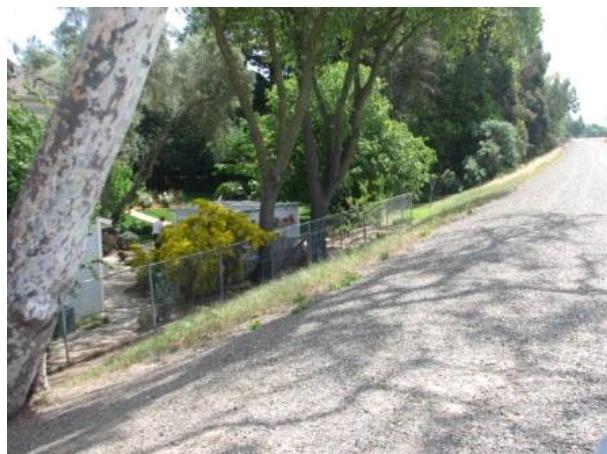
Levee Mile Report Line	139
Start Levee Mile	5.29
End Levee Mile	5.33
Location	Land Side
Category	Earthen Levee
Item	Vegetation
The landscape comes to the toe of the levee. Photo taken spring 2012.	
johngw_s_20120504_768.jpg

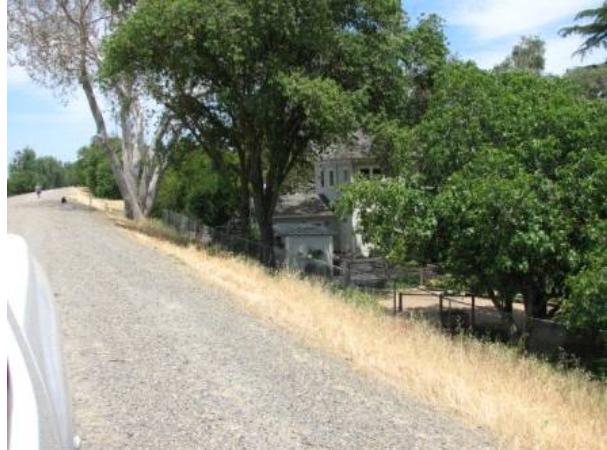
Levee Mile Report Line	140
Start Levee Mile	5.31
End Levee Mile	5.31
Location	Land Side
Category	Earthen Levee
Item	Encroachments
The building encroaches into the levee.	
<i>johngw_s_20120313_084.jpg</i>

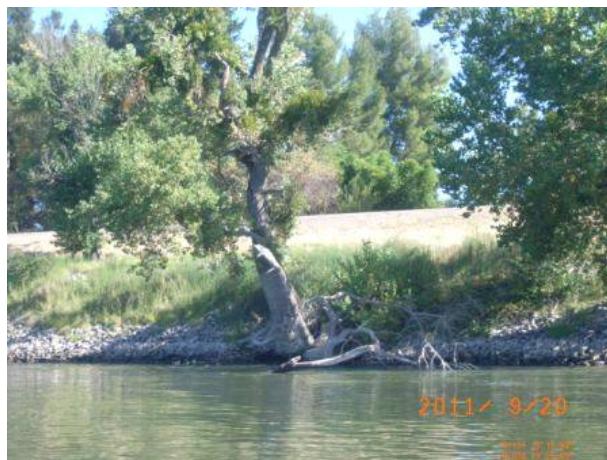
USACE 2011 Photo #1

Levee Mile Report Line	142
Start Levee Mile	5.35
End Levee Mile	5.35
Location	Water Side
Category	Supplemental
Item	USACE Erosion Survey

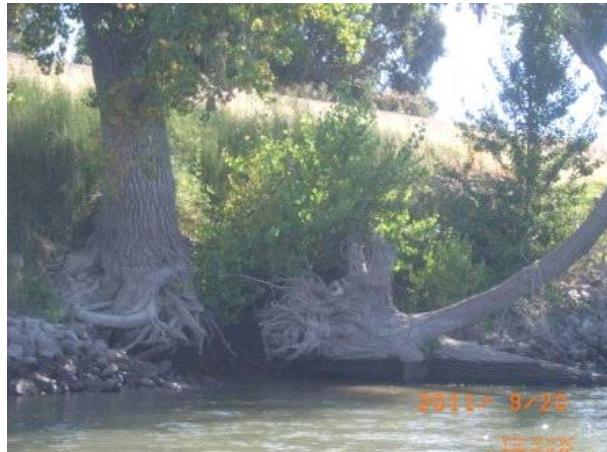
USACE 2011 Photo #2

Levee Mile Report Line	142
Start Levee Mile	5.35
End Levee Mile	5.35
Location	Water Side
Category	Supplemental
Item	USACE Erosion Survey

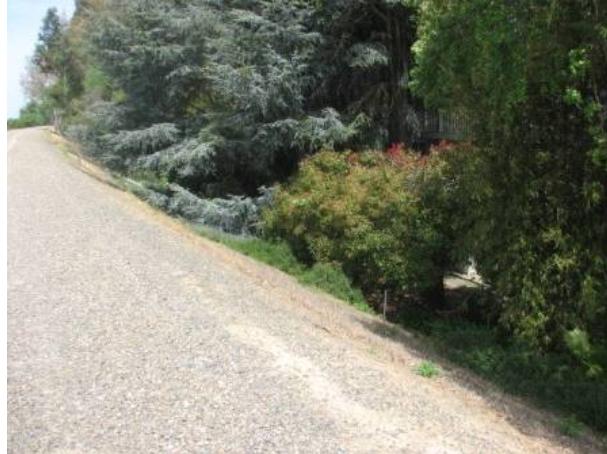
Levee Mile Report Line	143
Start Levee Mile	5.40
End Levee Mile	5.44
Location	Land Side
Category	Earthen Levee
Item	Vegetation
The cedar tree covers the levee slope blocks visibility. Photo taken spring 2012.	
johngw_s_20120504_769.jpg

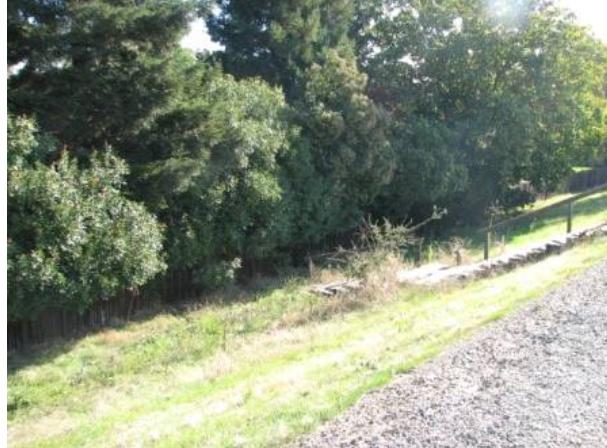
Levee Mile Report Line	148
Start Levee Mile	5.55
End Levee Mile	5.58
Location	Land Side
Category	Earthen Levee
Item	Vegetation
The landscape and fence blocks the view of the toe. Fall 2011	
johngw_s_20120313_085.jpg

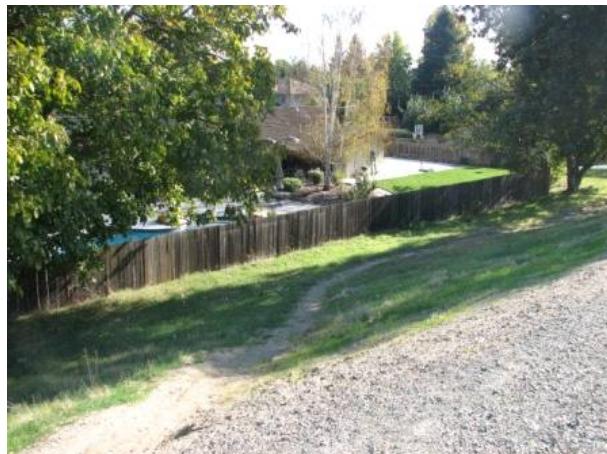
Levee Mile Report Line	149
Start Levee Mile	5.58
End Levee Mile	5.60
Location	Land Side
Category	Earthen Levee
Item	Encroachments
A solid fence was built at the toe of the levee. Fall 2011	
johngw_s_20120313_086.jpg

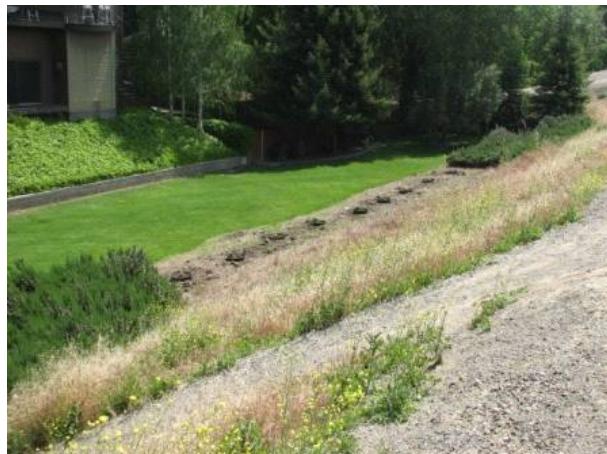
Levee Mile Report Line	150
Start Levee Mile	5.98
End Levee Mile	6.06
Location	Land Side
Category	Earthen Levee
Item	Vegetation
A newly planted garden at the toe of the levee. Photo taken spring 2012.	
johngw_s_20120504_772.jpg

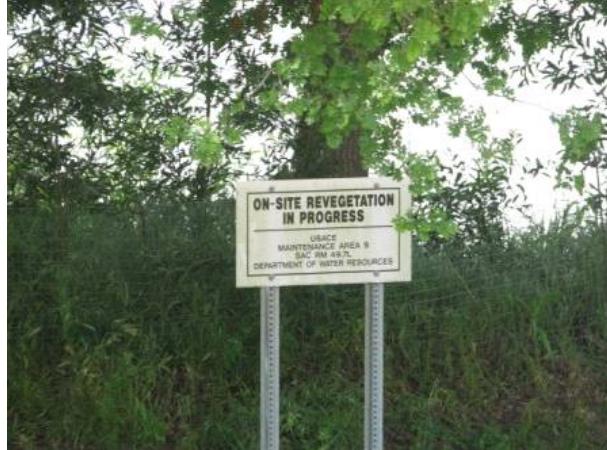
A revegetation site. Photo taken spring 2012.

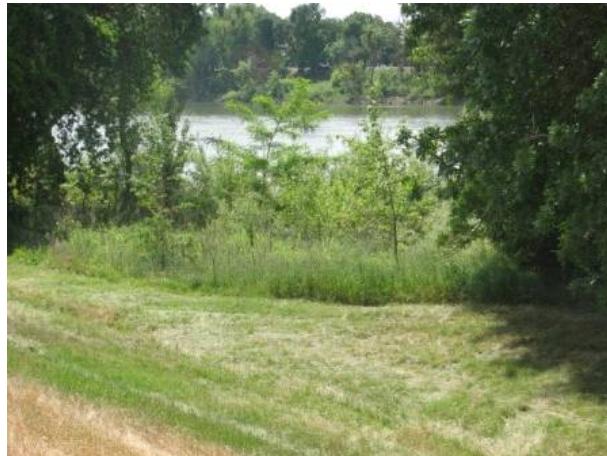
Levee Mile Report Line	151
Start Levee Mile	6.20
End Levee Mile	6.28
Location	Water Side
Category	Earthen Levee
Item	Vegetation

The slope has been mowed to the revegetation site.

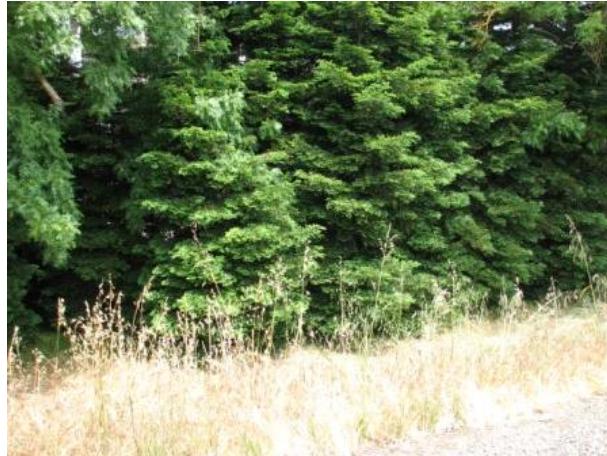
Levee Mile Report Line	152
Start Levee Mile	6.90
End Levee Mile	6.90
Location	Land Side
Category	Earthen Levee
Item	Vegetation

The redwood trees are blocking the view.

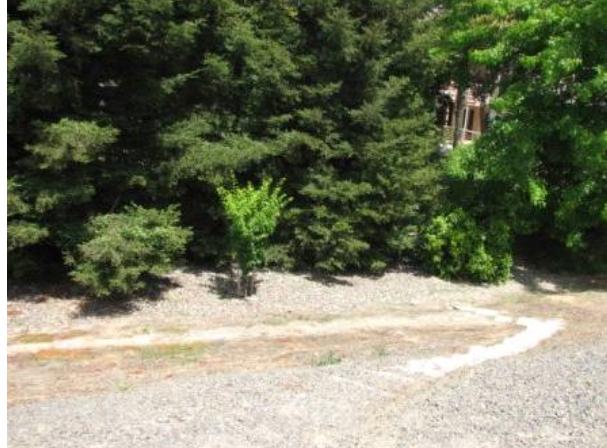
Levee Mile Report Line	154
Start Levee Mile	7.32
End Levee Mile	7.32
Location	Land Side
Category	Earthen Levee
Item	Vegetation
The landscape is borderline at the easement of the toe. Photo taken spring 2012.	
<i>johngw_s_20120504_775.jpg</i>

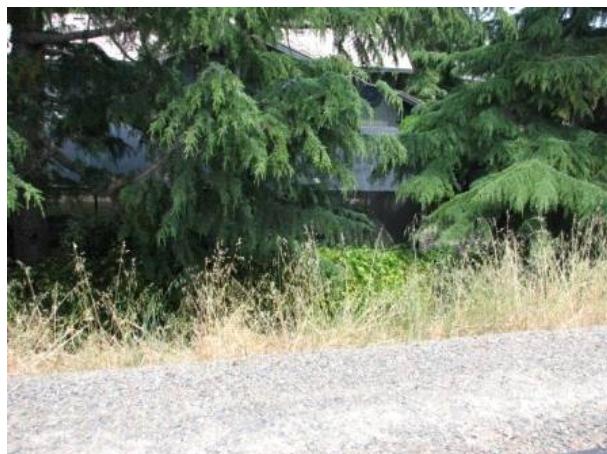
Levee Mile Report Line	155
Start Levee Mile	7.38
End Levee Mile	7.39
Location	Land Side
Category	Earthen Levee
Item	Encroachments
A solid fence and landscape need to be trimmed.	
<i>johngw_s_20120313_088.jpg</i>

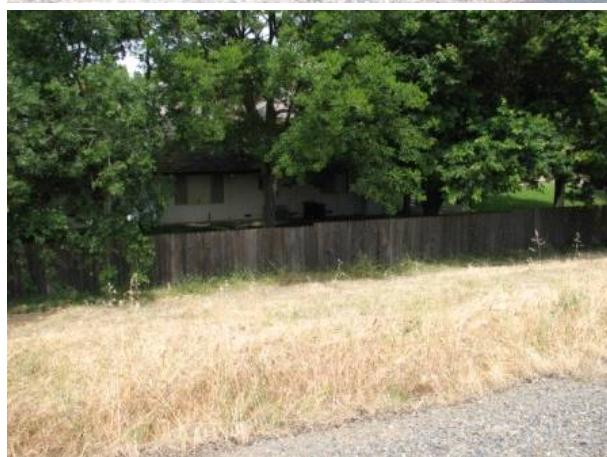
Levee Mile Report Line	156
Start Levee Mile	7.52
End Levee Mile	7.55
Location	Land Side
Category	Earthen Levee
Item	Encroachments
Another solid fence along the slope.	
<i>johngw_s_20120313_089.jpg</i>

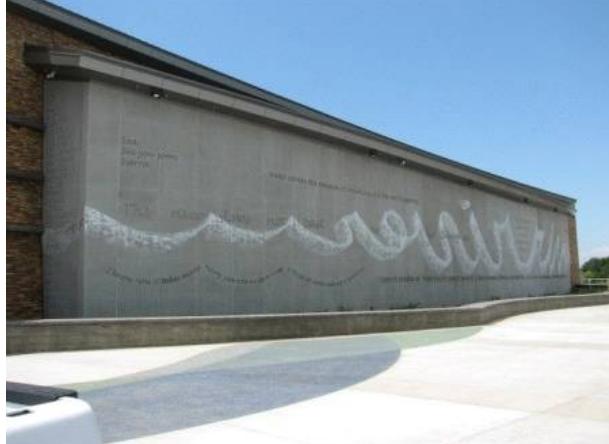
Levee Mile Report Line	159
Start Levee Mile	8.60
End Levee Mile	8.60
Location	Crown
Category	Earthen Levee
Item	Encroachments
This is the new East Bay MUD pumping plant.

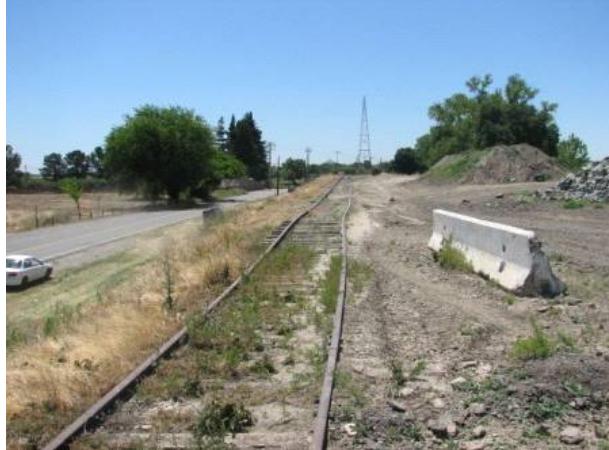
Levee Mile Report Line	160
Start Levee Mile	8.85
End Levee Mile	10.63
Location	Crown
Category	Earthen Levee
Item	Encroachments
The railroad tracks are on the crown of the levee from here to Cliffs marina.

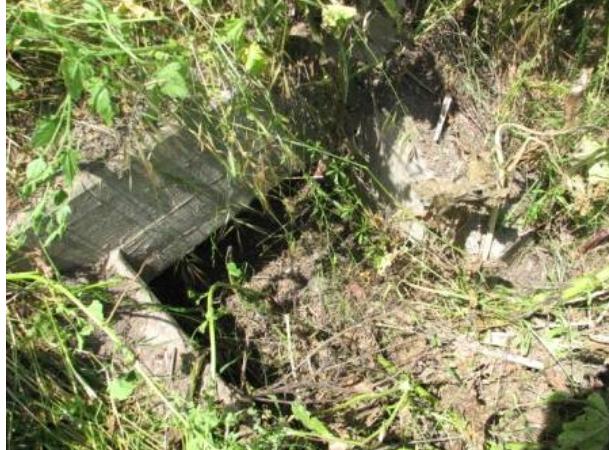
Levee Mile Report Line	161
Start Levee Mile	8.98
End Levee Mile	8.98
Location	Land Side
Category	Earthen Levee
Item	Encroachments
The drain outlet on the east side of Freeport Blvd. Photo taken spring 2012.

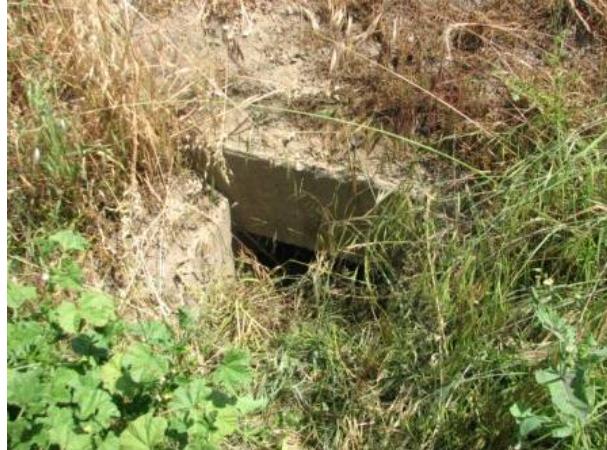
Levee Mile Report Line	161
Start Levee Mile	8.98
End Levee Mile	8.98
Location	Land Side
Category	Earthen Levee
Item	Encroachments
The drain inlet at the toe of the levee.	
johngw_s_20120504_777.jpg

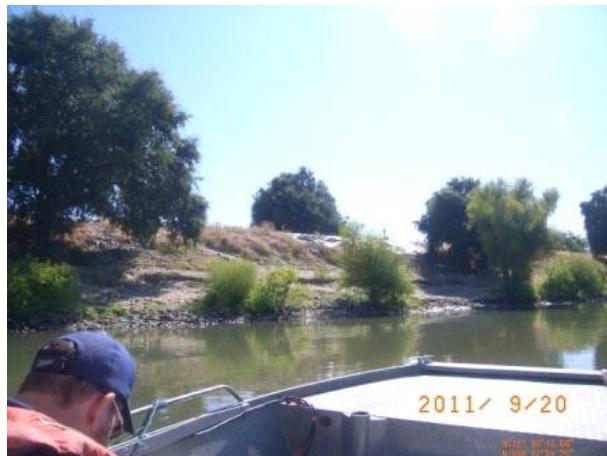
USACE 2011 Photo #1

Levee Mile Report Line	162
Start Levee Mile	9.07
End Levee Mile	9.22
Location	Water Side
Category	Supplemental
Item	USACE Erosion Survey

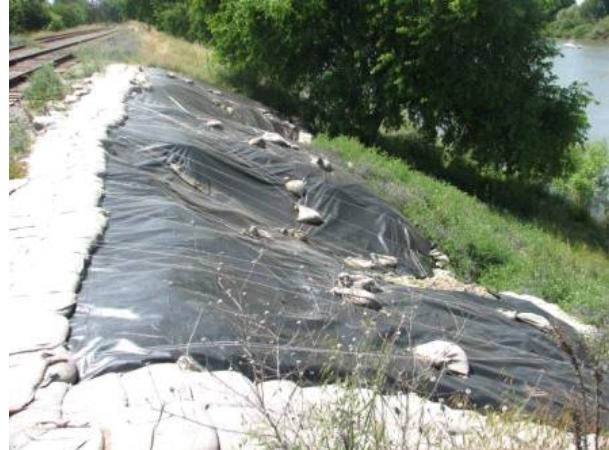
Levee Mile Report Line	163
Start Levee Mile	9.20
End Levee Mile	9.20
Location	Water Side
Category	Earthen Levee
Item	Erosion / Bank Caving
The erosion site has a new rain coat placed on this winter. Photo taken spring 2012.	
<i>johngw_s_20120504_781.jpg</i>

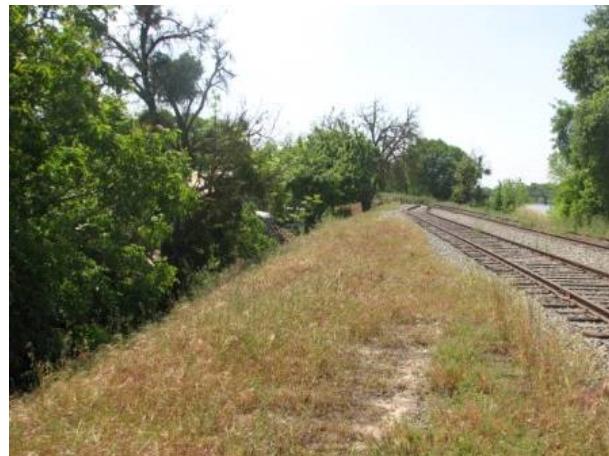
Levee Mile Report Line	164
Start Levee Mile	9.31
End Levee Mile	9.71
Location	Land Side
Category	Earthen Levee
Item	Encroachments
This view is the upstream side of Freeport Photo taken spring 2012.	
<i>johngw_s_20120504_782.jpg</i>

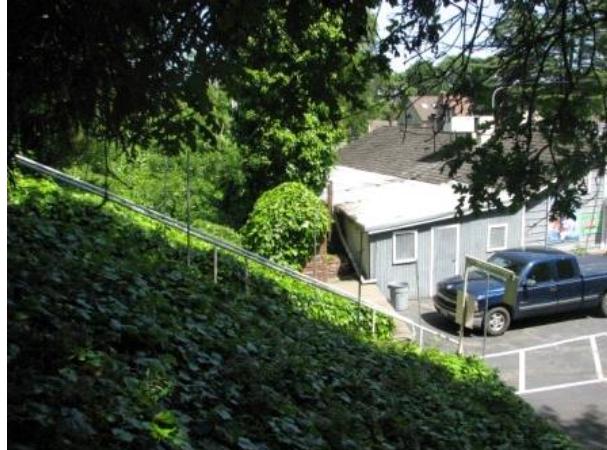
Levee Mile Report Line	181
Start Levee Mile	9.67
End Levee Mile	9.67
Location	Land Side
Category	Earthen Levee
Item	Encroachments
The Freeport Bait shop is at the toe of the levee. Photo taken spring 2012.	
johngw_s_20120504_780.jpg

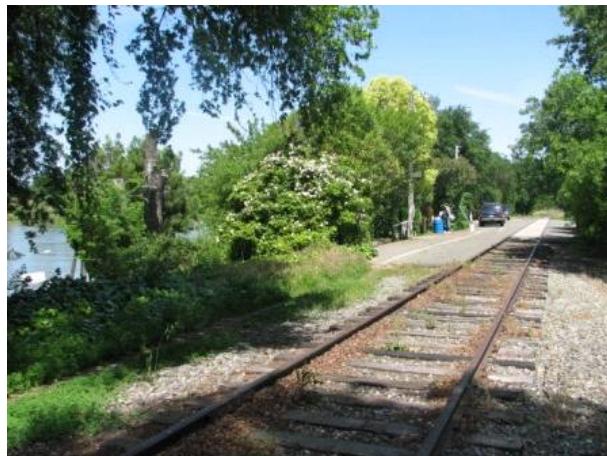
Levee Mile Report Line	182
Start Levee Mile	9.67
End Levee Mile	9.69
Location	Water Side
Category	Earthen Levee
Item	Vegetation
There are trees, shrubs and groundcover on the waterside slope. Photo taken spring 2012. This Freeport Marina.	
johngw_s_20120504_779.jpg

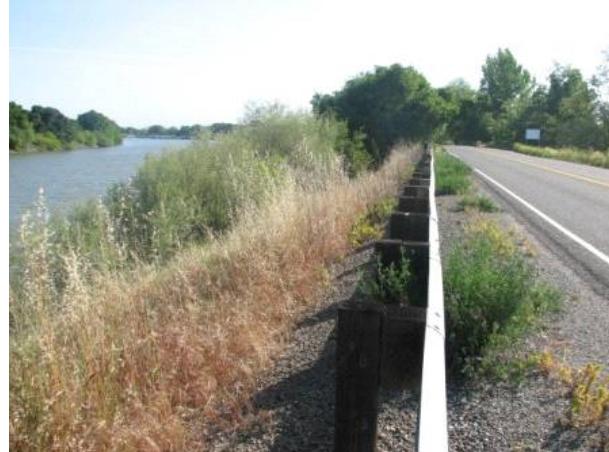
johngw_s_20120504_789.jpg

Levee Mile Report Line	184
Start Levee Mile	10.63
End Levee Mile	19.52
Location	Water Side
Category	Earthen Levee
Item	Vegetation

The grasses are taller than 12". Photo taken spring 2012.

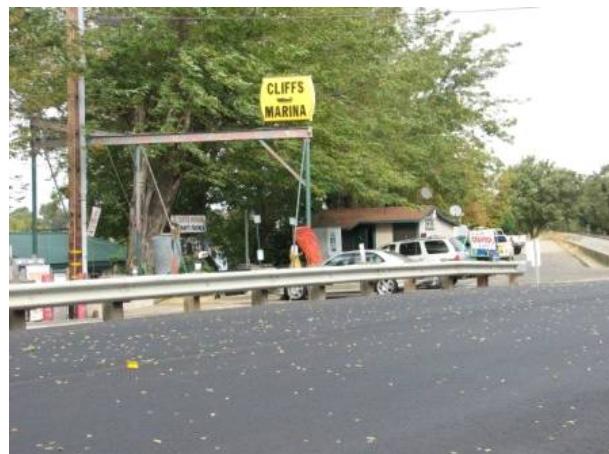
johngw_s_20120313_092.jpg

Levee Mile Report Line	185
Start Levee Mile	10.64
End Levee Mile	10.64
Location	Water Side
Category	Earthen Levee
Item	Encroachments

Cliffs marina is on the waterside of the levee crown. The levee crown is HWY 160 and at this point the HWY drops off the crown. Fall 2011

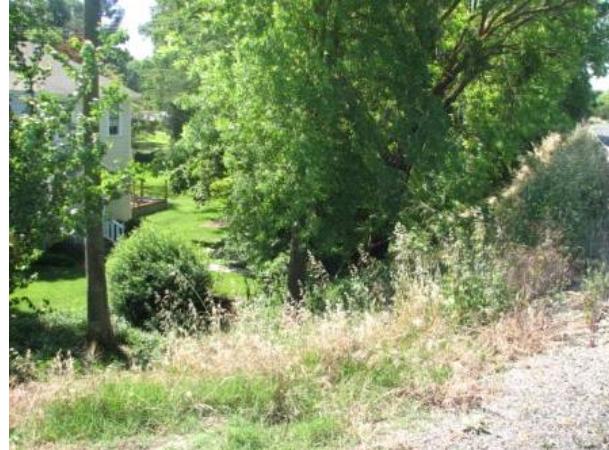
johngw_s_20120504_784.jpg

A view of the landscape. Photo taken spring 2012.
